EXERCISE DESERT ROCK LAS VEGAS NV

EXERCISE DESERT ROCK V. JANUARY-JUNE 1953. VOLUME I. OPERATIONS--ETC(U)

Exercise Desert Rock V

Volume I - Operations

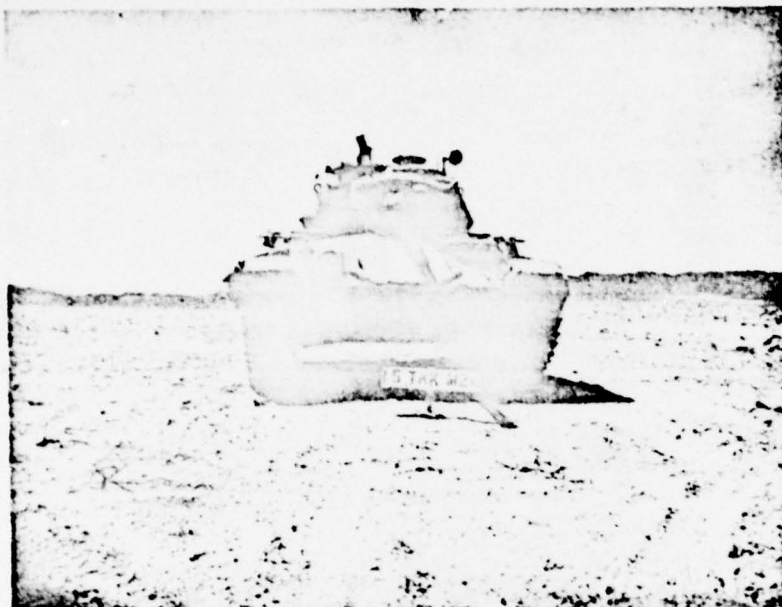
Tank, Light M24 w/  
75 MM Gun mounted  
500 yds from Ground  
Zero

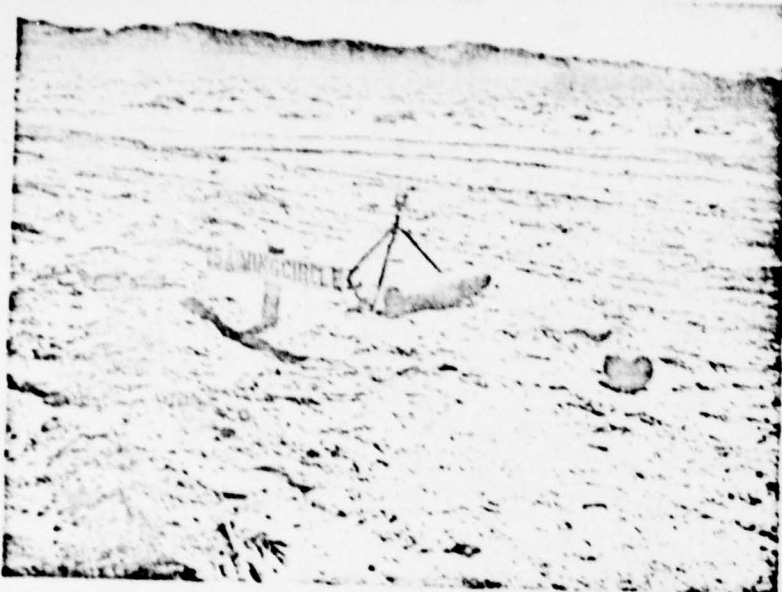
Aiming Circle M1  
1500 yds from Ground  
Zero

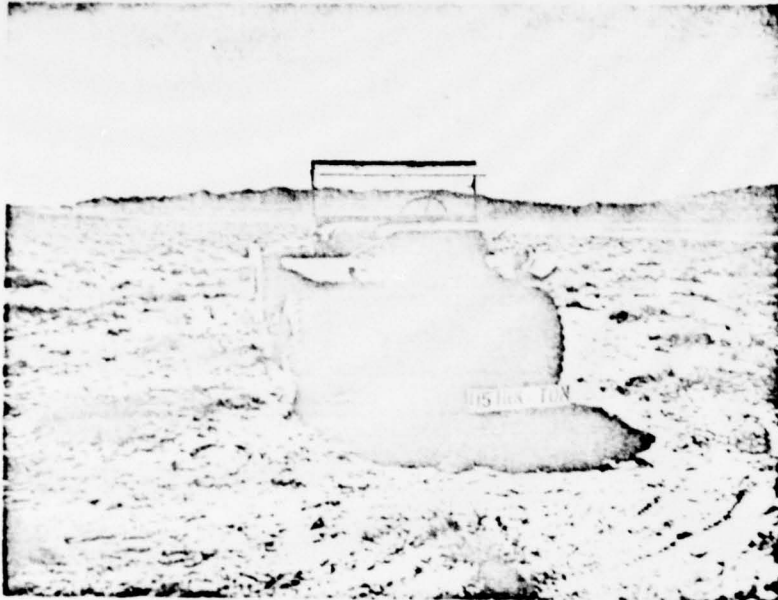
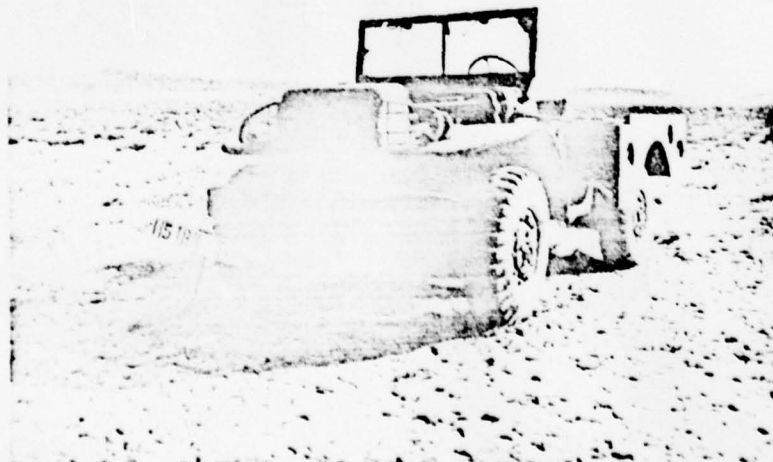
Truck, 3/4, 4x4  
Weapons Carrier  
1500 yds from  
Ground Zero

Windshield blown  
completely out,  
Frame bent, paint  
burned and blistered  
on parts facing  
Ground Zero. Tail  
gate blown off.

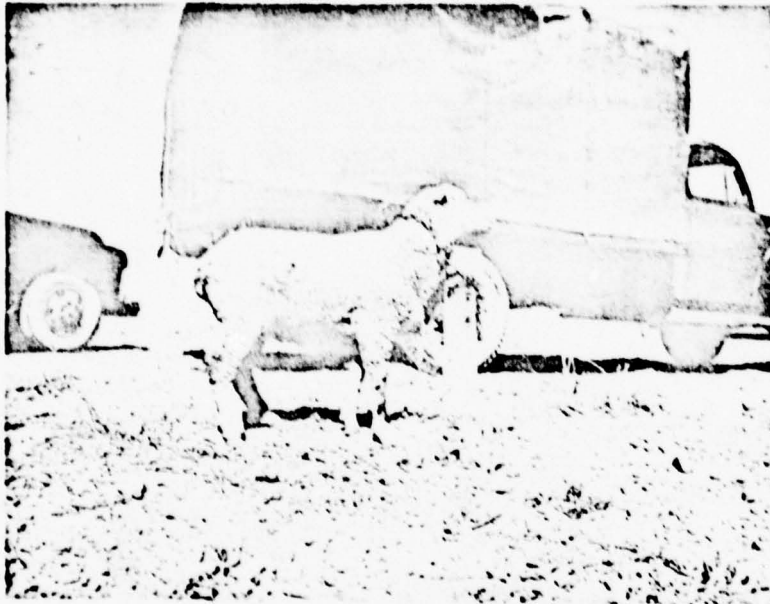
C-1 at 500 yds. This sheep had a fractured right metatarsal bone. The fracture was reduced with a plaster of Paris cast. Following the detonation the right rear leg was dismembered at the line drawn above the cast.

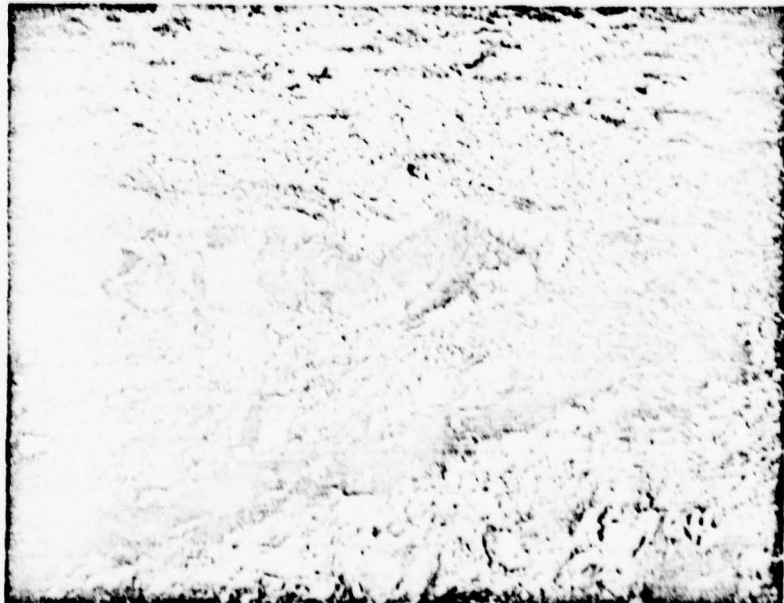
C-1 at 500 yds. This sheep following the detonation was blown back approx 200 yds from the stake. The abdominal cavity was torn open, and the right rear leg was located 50 yds away from the carcass.

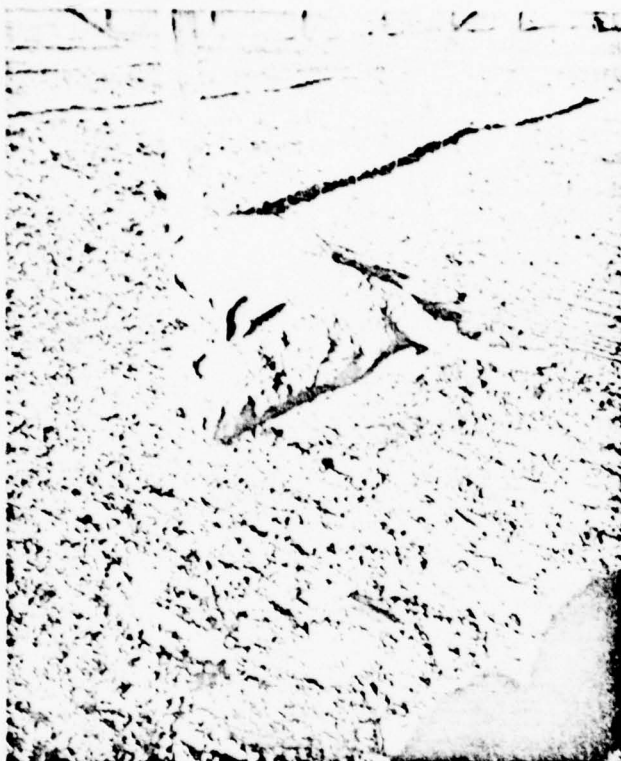
C-5 at 500 yds. This sheep had first degree burns on the face and negligible wool burns. On first observation it was suffering no other visible effects.

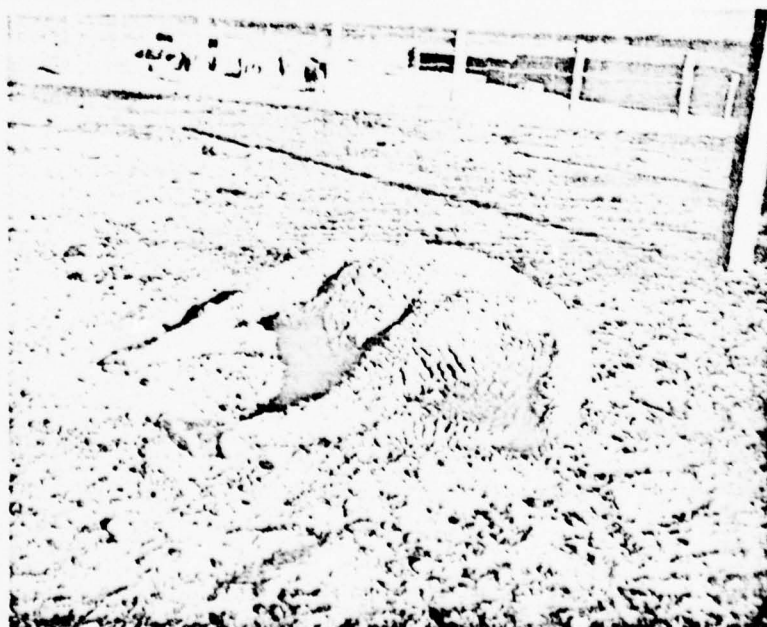
C-5 at 500 yds. This is another picture of the above animal. The evidence of diarrhea seen here developed 26 Mar, and in-co-ordination developed the morning of 27 Mar followed by death the afternoon of 27 Mar.

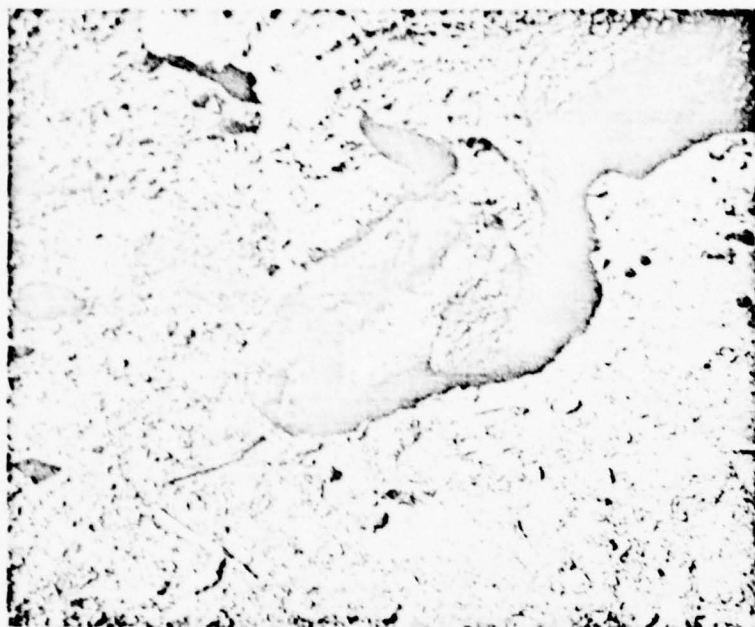
C-2 at 1000 yds. This is a close-up of the preceding sheep shortly before death.

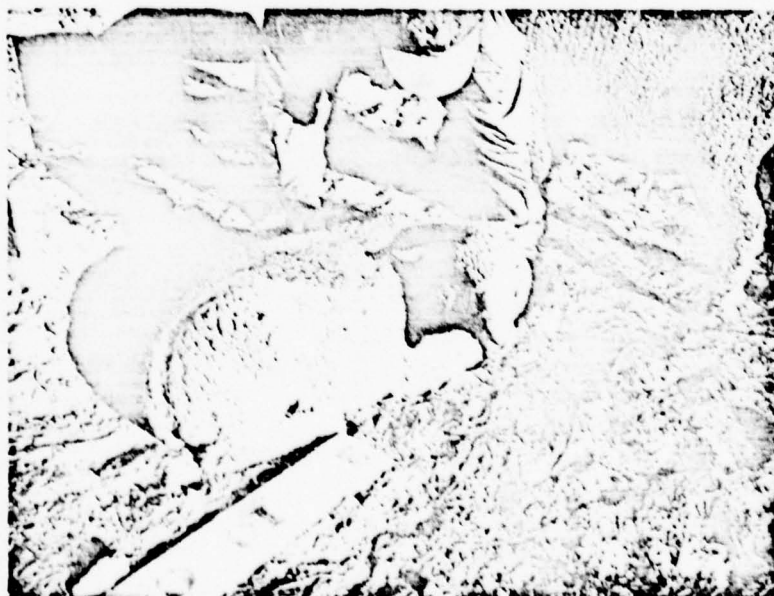
C-3 at 1000 yds. Second degree burns on the face and extensive wool burns. Death occurred 26 Mar. and was attributed to acute lethal radiation sickness.

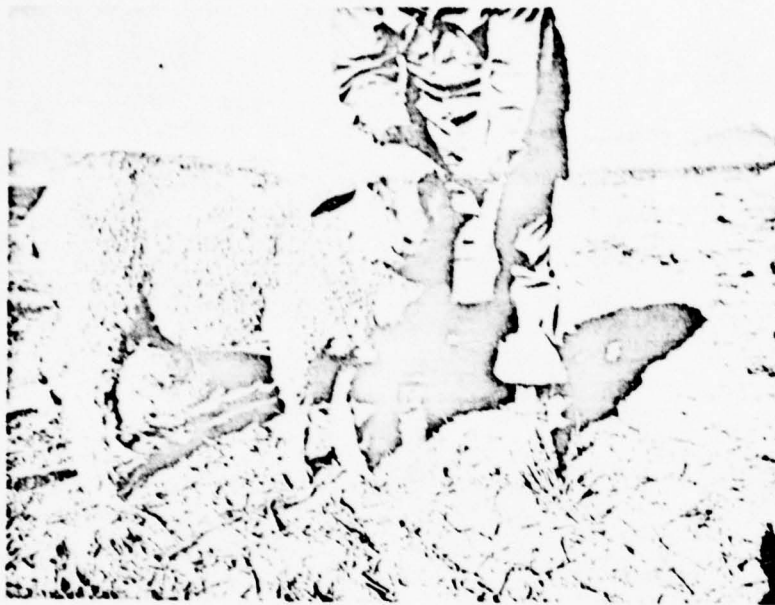
C-1 at 1000 yds.  
This sheep suffered  
third degree burns  
on the face and ex-  
tensive wool burns.  
It became prostrate  
from blast effects  
the afternoon of the  
detonation and was  
destroyed to prevent  
further suffering.

At 1000 yards the sheep at position C-1 had third degree burns on the face and extensive wool burns. It was further suffering from an extensive shrammel type wound of the right shoulder. This animal died 19 April with death being attributed to radiation sickness. The dose of radiation this animal received was 5641 r. At position C-2 the sheep had third degree profile burns on the right side of the face and extensive wool burns. It developed in-coordination and diarrhea the morning of 21 April and became prostrate the afternoon of 21 April and died during the night of 21 April. Death was attributed to acute radiation sickness. The dose of radiation the animal received was 3913 r. At position C-3 the sheep received extensive wool burns on the back. It developed in-coordination the morning of 20 April and diarrhea the morning of 20 April. Prostration ensued the afternoon of 21 April followed by death the night of 21 April. The wool burns received by this animal were of little consequence and this can be considered a typical case of acute radiation sickness. The radiation dosage for this animal was 2038 r. The sheep at position C-4 has shown no illness of any nature. It's radiation dosage was 369 r. The sheep at position C-5 developed epilation 29

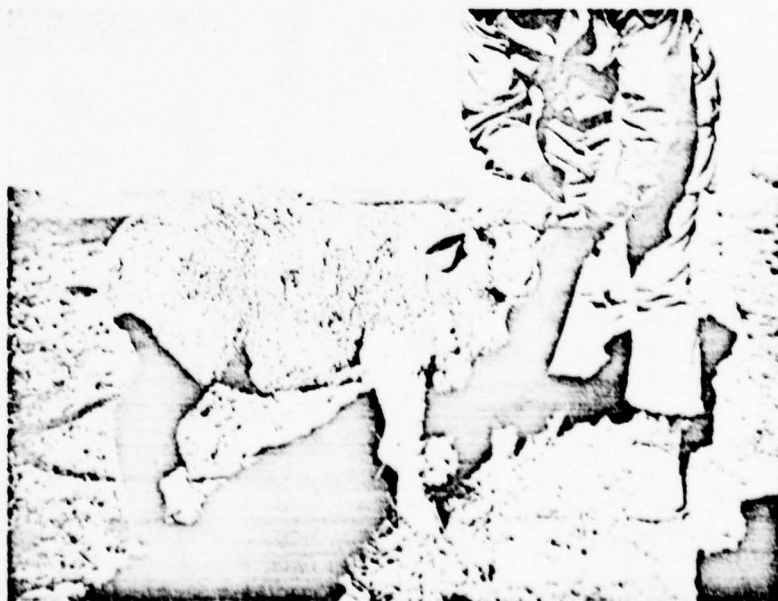
C-2 at 1000 yds. This  
sheep suffered third  
degree burns on the  
face.

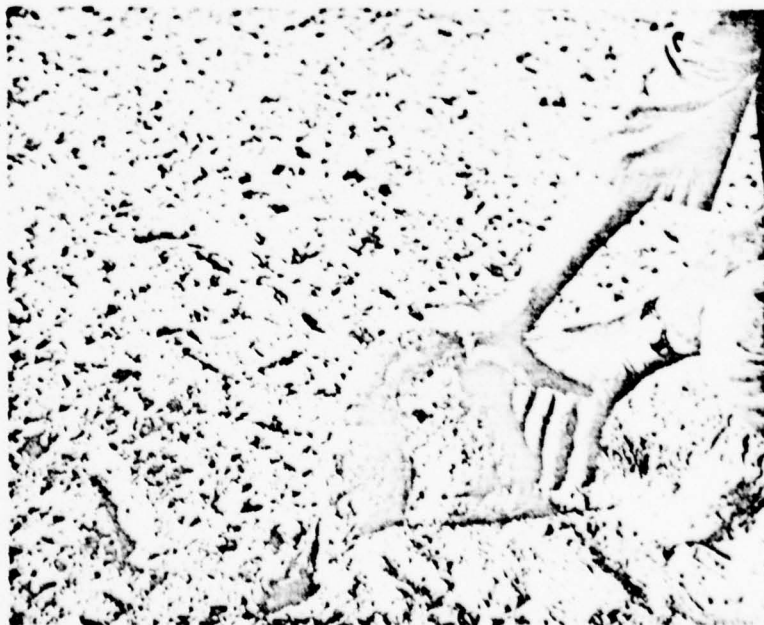
C-4 at 1000 yds. This is a picture of the above animal taken shortly before death. Note the third degree burns on the face and ear.

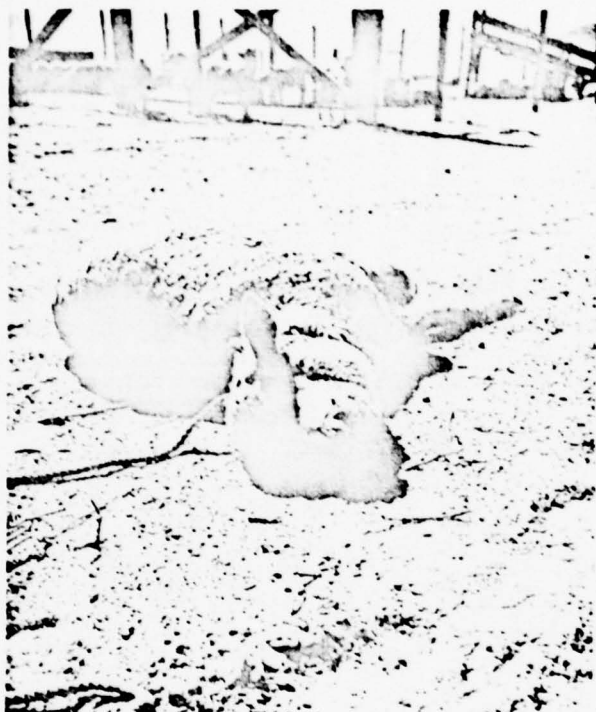
C-3 at 1000 yds. This is a picture of the preceding sheep taken after death. From all outward appearances there was little wrong with this animal.

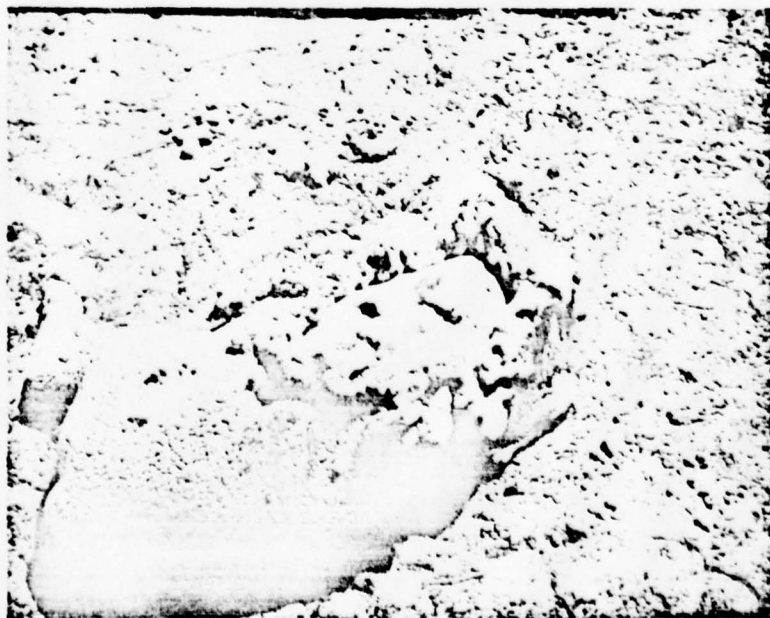
C-1 at 1500 yds. This is a picture of the above sheep taken a few hrs before death. The epilation seen here is quite extensive.

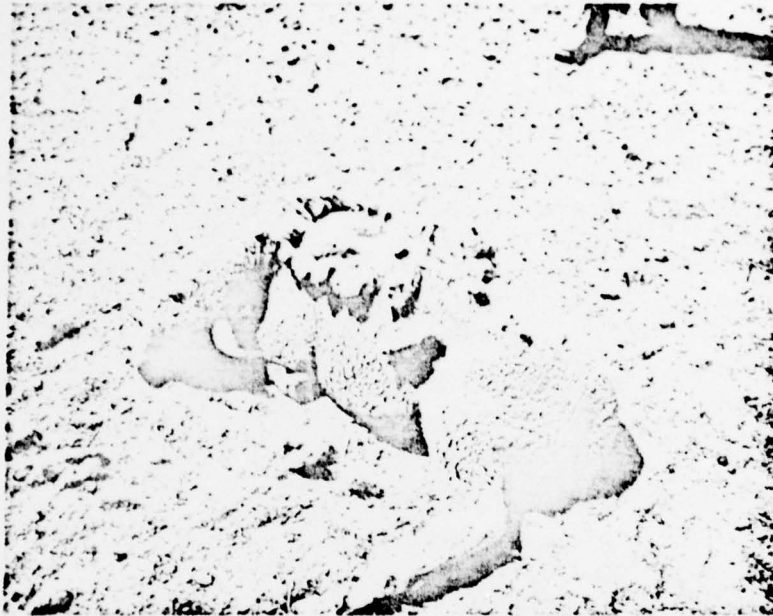
C-1 at 1500 yds.  
This is another picture of the preceding sheep. Note its comatose condition. The epilation would have continued to be progressive if death had not intervened.

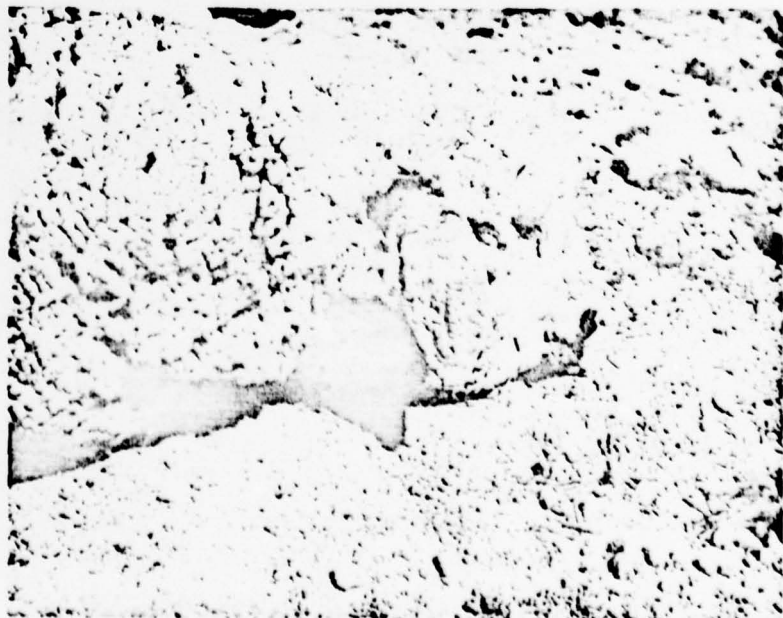
C-1 at 1500 yds.  
This is the same sheep as viewed in the three preceding pictures. The nasal discharge is hemorrhagic in nature.

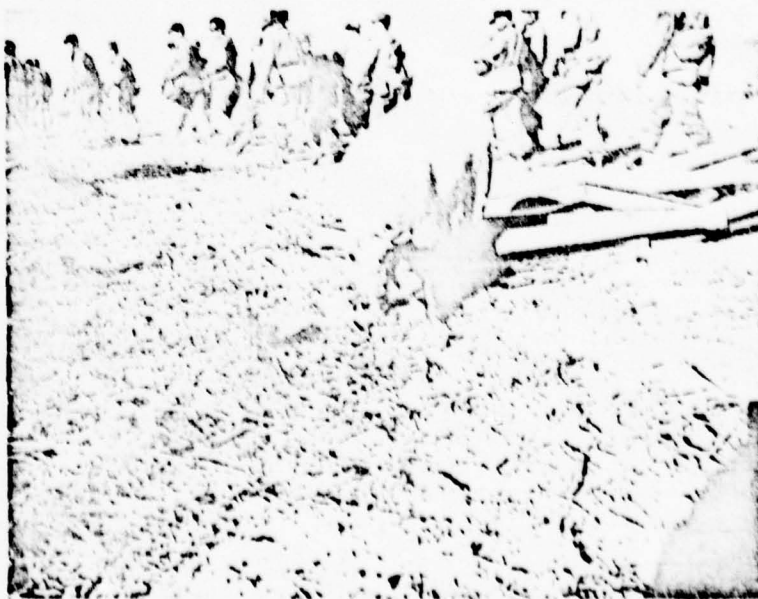
C-3 at 2000 yds.  
This sheep had second degree burns on the face. Note collapse of sheep pens.

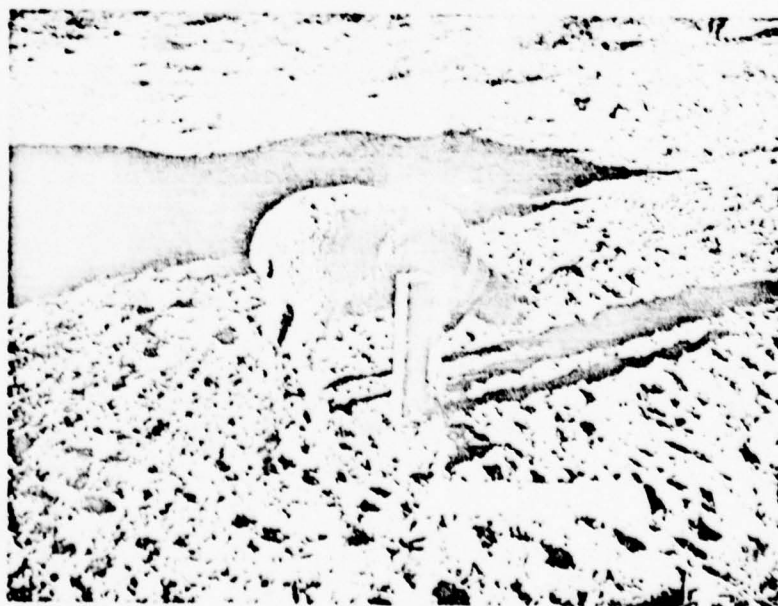
C-1 at 2000 yds. The sheep at this position had extensive wool burns across the back and one side.

The sheep at position C-1 2000 yards, had slight wool burns.

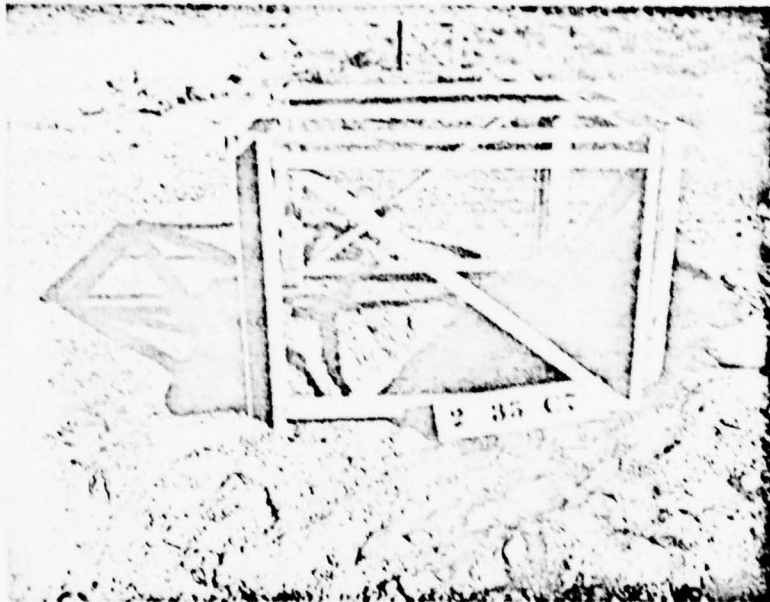
C-7 at 3500 yds.  
The sheep at this  
position had no visi-  
ble effects. Pen was  
undamaged.

The sheep at 3500 yards were all found to be normal.

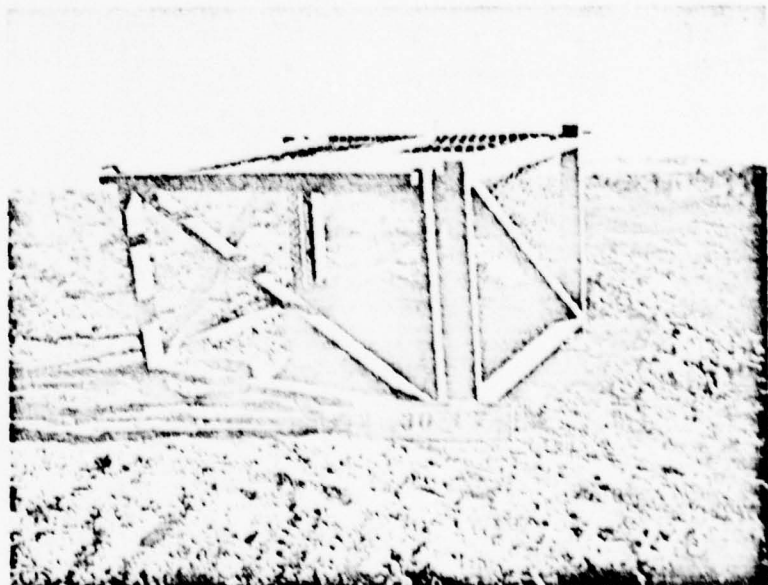
C-7 at 3000 yds. The  
sheep at this posi-  
tion had light wool  
burns across the back.  
Pen was undamaged.

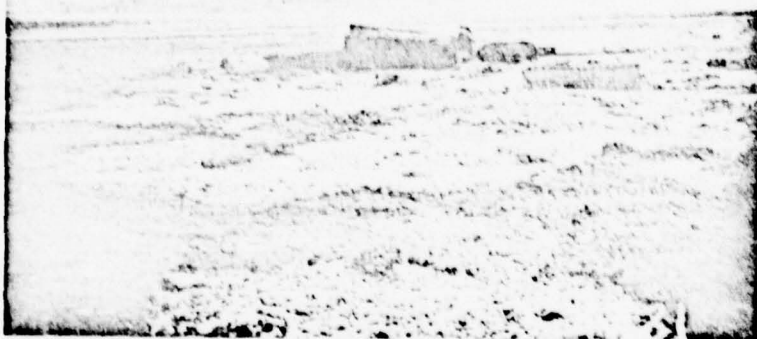
GZ. Tank, Mod M4A3  
w/76MM Gun. Major  
items completely  
destroyed. One track  
link, road wheel &  
Parts found around  
the 450 yd line.

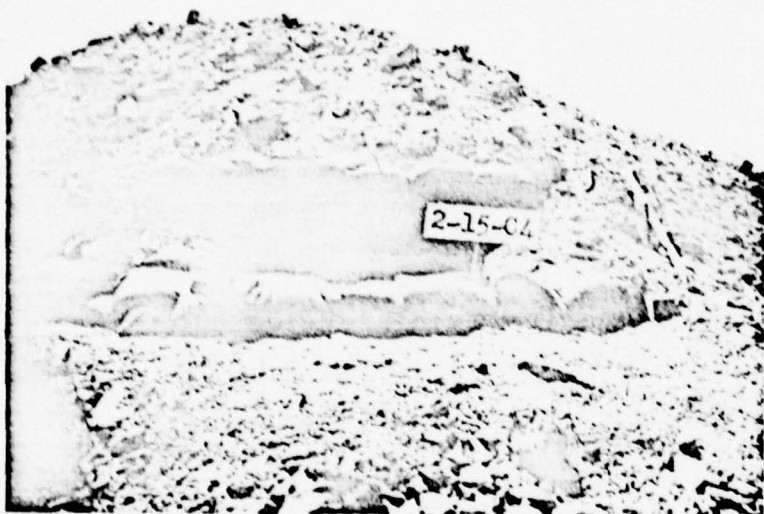
BEFORE

C-4 1,500 yds. Bunker  
facing GZ

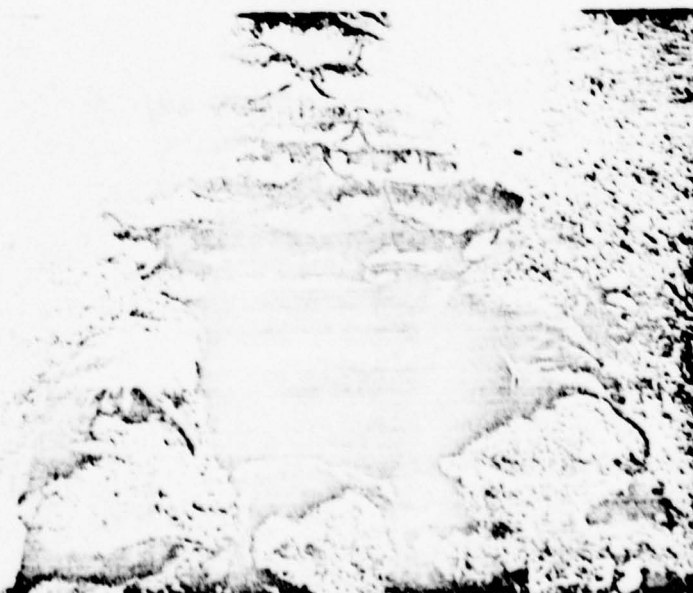
AFTER

C-4 1,500 yds. All  
sand bags destroyed,  
no structural weakening.

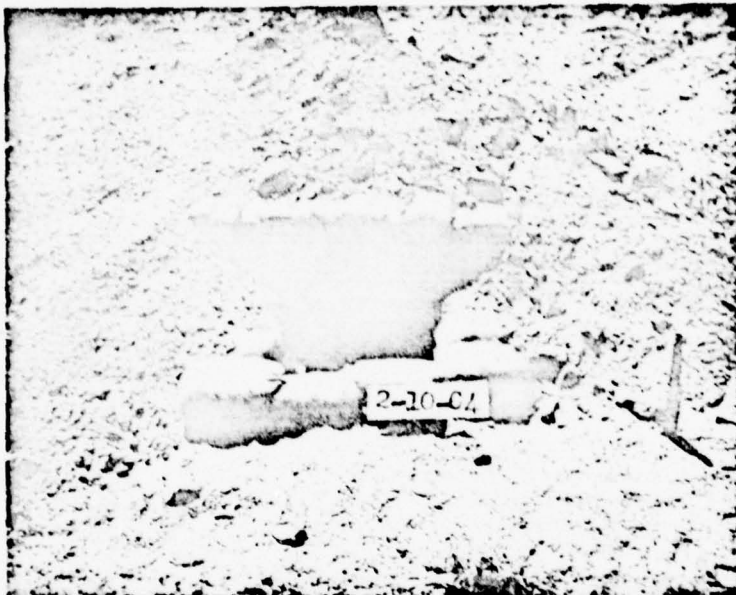
BEFORE

C-4 1,000 yds. Bunker  
facing GZ.

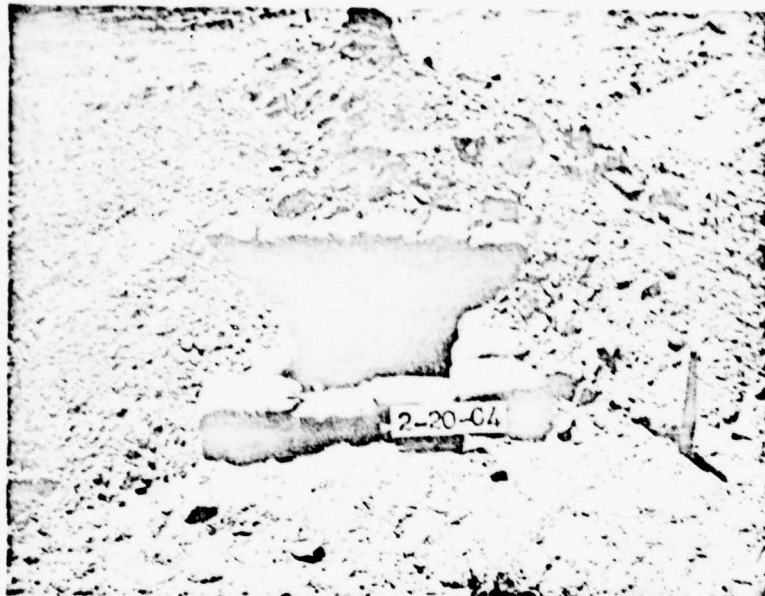
BEFORE

C-4 2,000 yds. Bunker  
facing GZ.

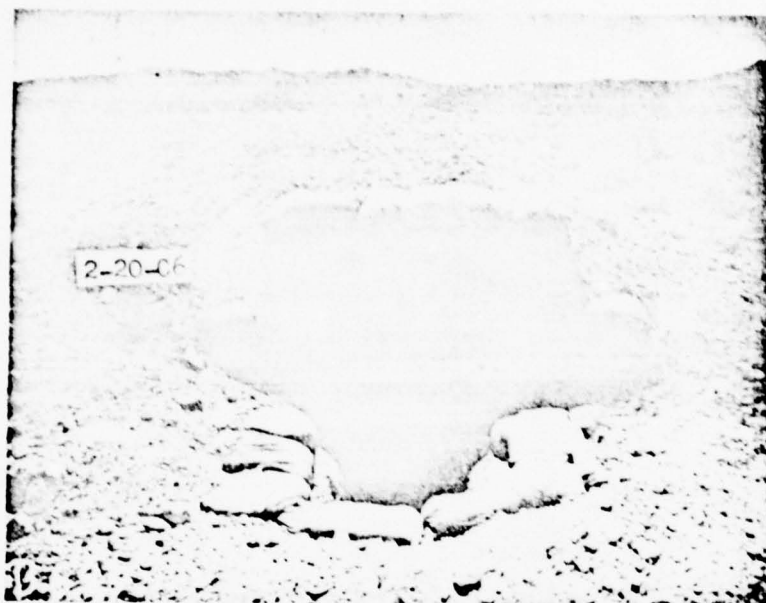
BEFORE

C-6 2,000 yds. Bunker  
facing GZ.

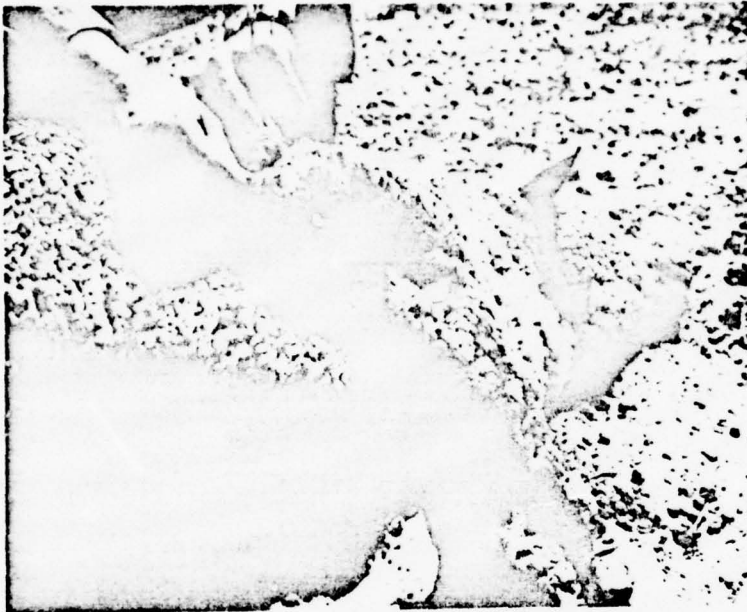
C-1, 1000 yds. This is a picture of the preceding animal showing the wound received. Death occurred 19 April and was attributed to radiation sickness.

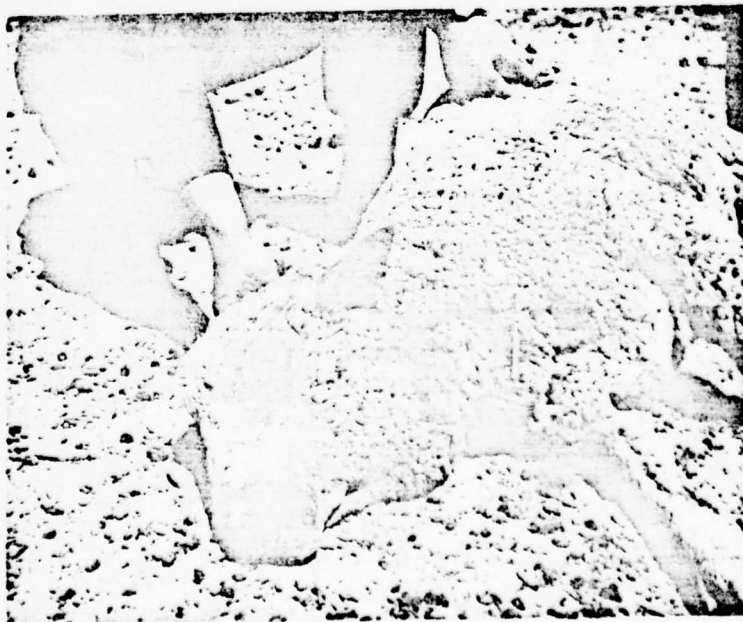
C-1, 1000 yds. This is another view of the above sheep showing the third degree burns on the face.

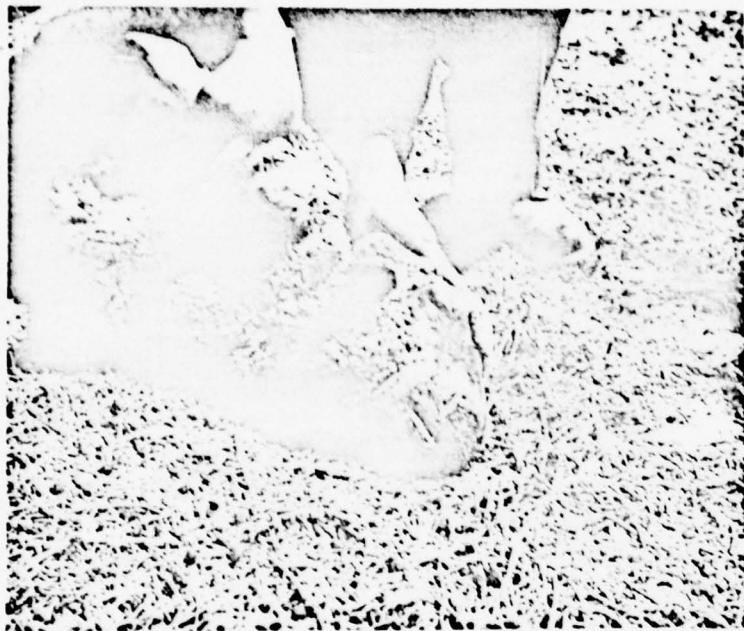
C-2, 1000 yds. This sheep had third degree burns on the face and extensive wool burns. Death occurred the night of 21 April, and was attributed to radiation sickness.

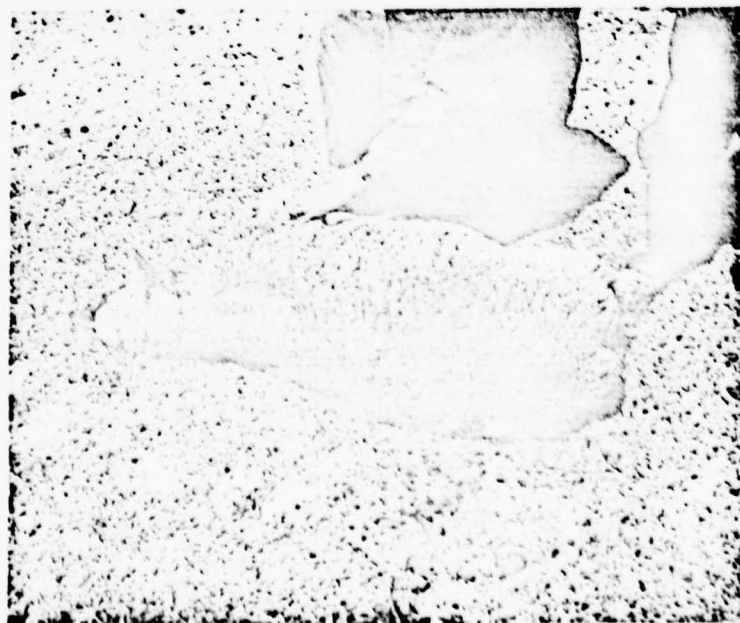
C-2, 1000 yds. This is another picture of the above animal showing the extensive wool burns.

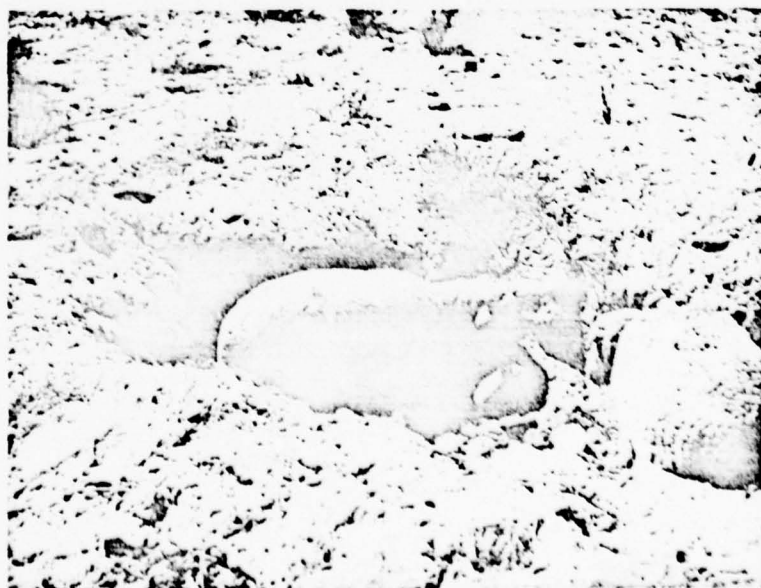
C-1 & 2, 1000 yds.  
Both these sheep suffered third degree burns on the face and extensive wool burns. The sheep on the left was originally at position C-1, 1000 yds before it broke loose after the shot. It was found to have an extensive shrapnel like wound over the right shoulder.

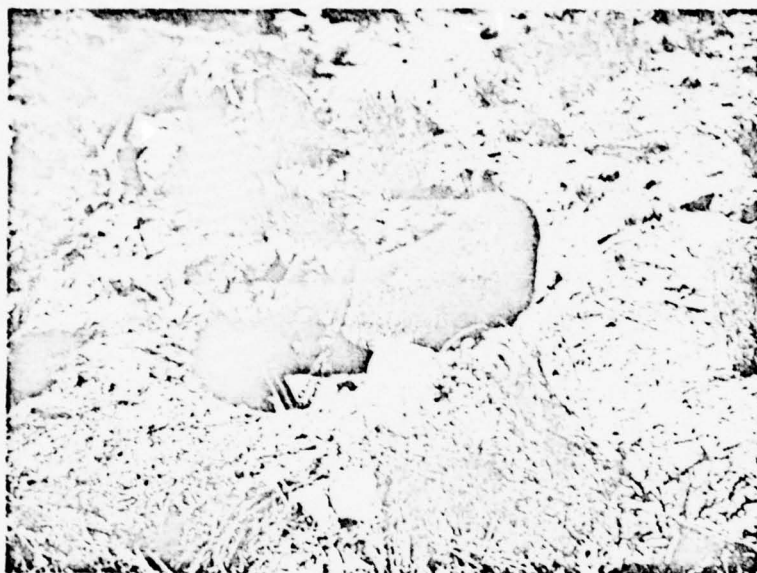
C-2, 1500 yds. This animal suffered third degree profile burns on the face and extensive wool burns. Epilation commenced 24 April followed by death 28 April. Radiation sickness was the cause of death.

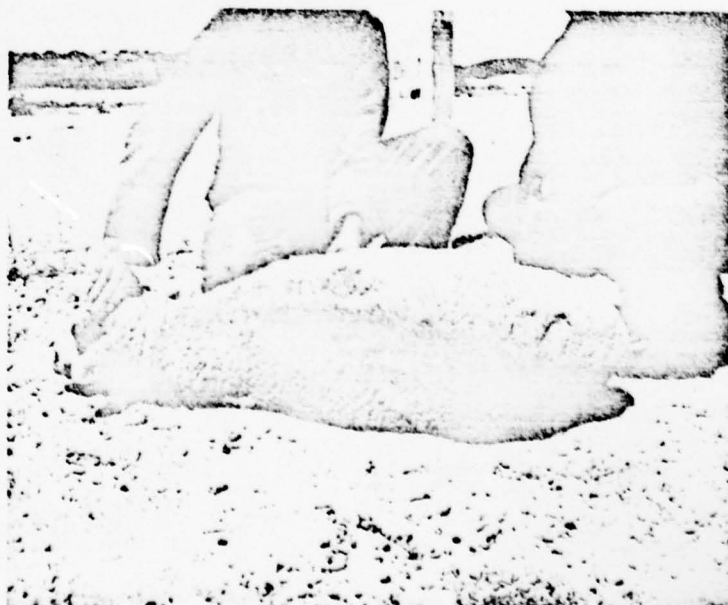
C-2, 1500 yds. This is a view of the above animal showing in detail the wool burns and third degree burns on the face.

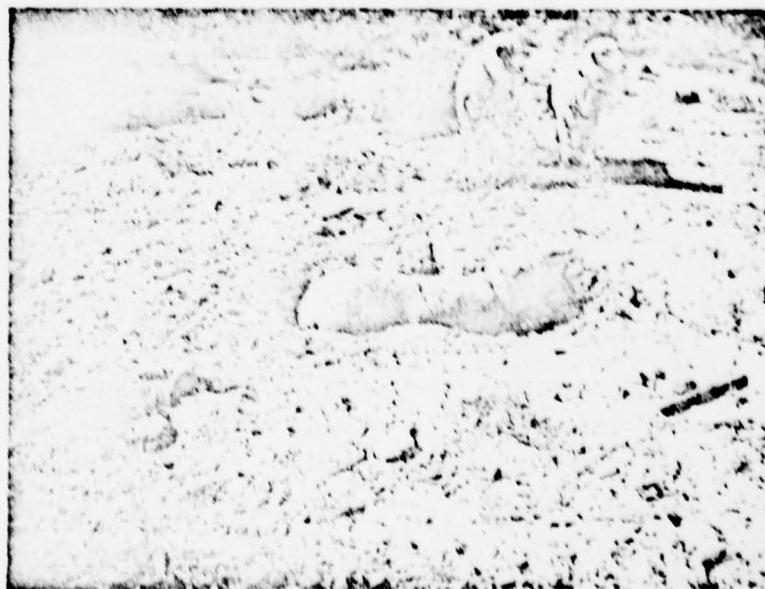
C-2, 2000 yds. The sheep in the foreground was at position C-2, 2000 yds, and was normal. The one on the left suffered slight wool burns, and was from C-1, 2000 yds. The one on the right was normal, and was from C-2, 2000 yds.

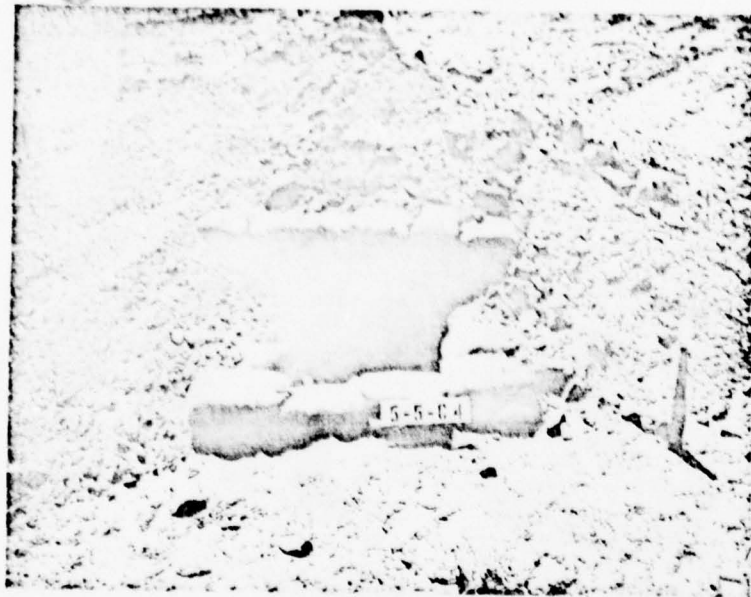
C-4 Bunker 500 yards  
from GZ. Entrance  
facing GZ.

Totally collapsed.

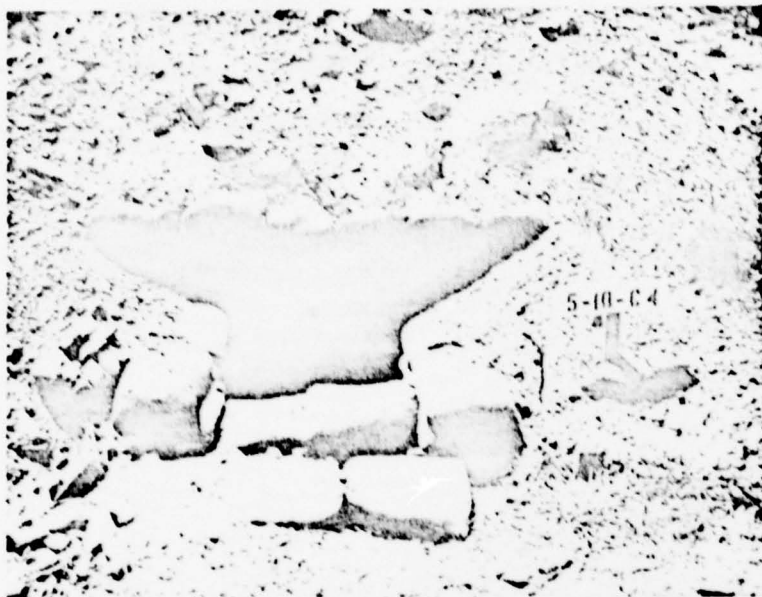
BEFORE  
C-4 Bunker 1000 yards  
from GZ. Entrance  
facing GZ.

All sandbags destroyed.  
Entrance blocked by  
sandbag fill falling  
into it.

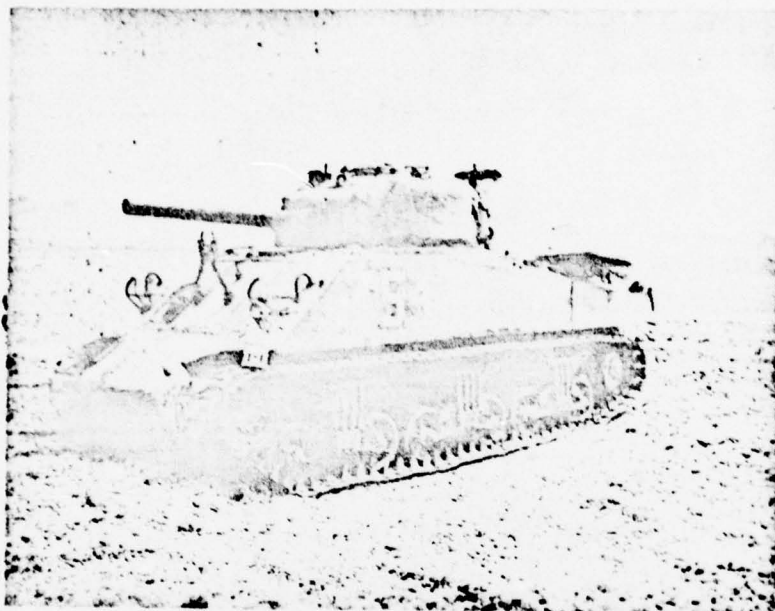
Tank, M4A3, facing  
GZ at 500 yards.

Displaced 30 feet.  
Turret sheared off  
and thrown 20 feet  
from tank. Paint sand-  
blasted off.

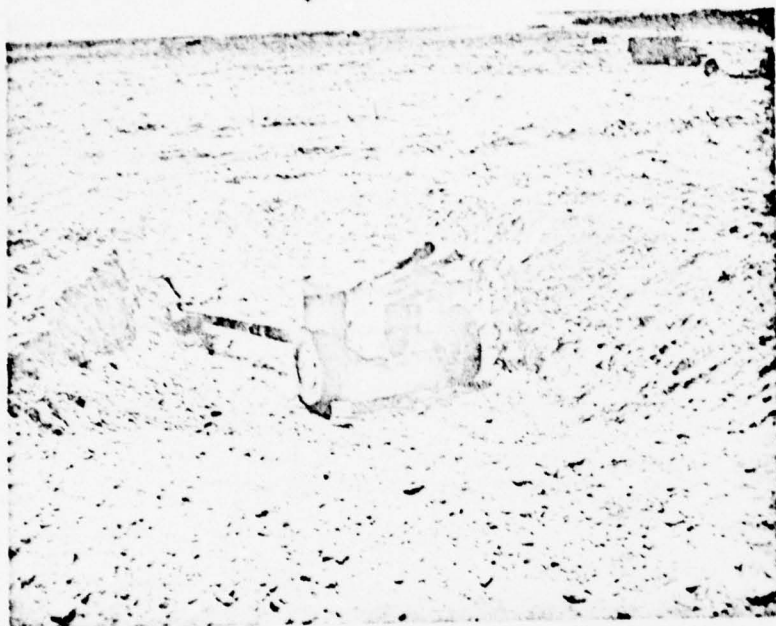
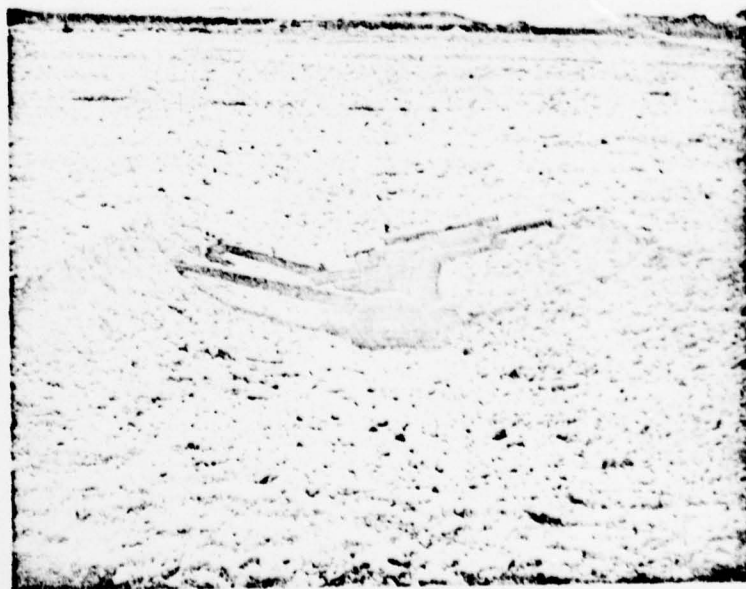
105 MM Howitzer with  
sight, dug in 500  
yards from GZ.

Turned 90 degrees in  
emplacement. Pushed  
back 5 feet. Appa-  
rently operable.

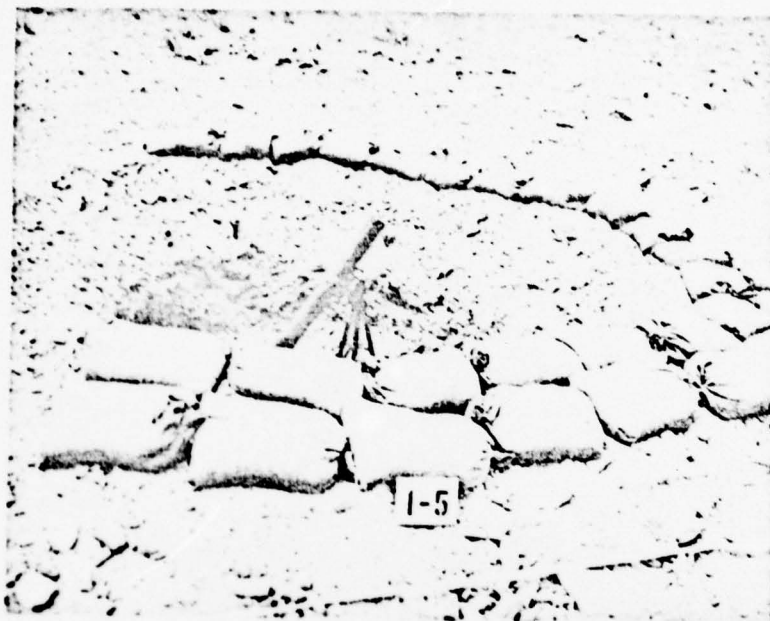
81 MM mortar in em-  
placement 550 yards  
from GZ.

Tube detached from  
base plate and  
thrown half out of  
emplacement. Bipod  
damaged.

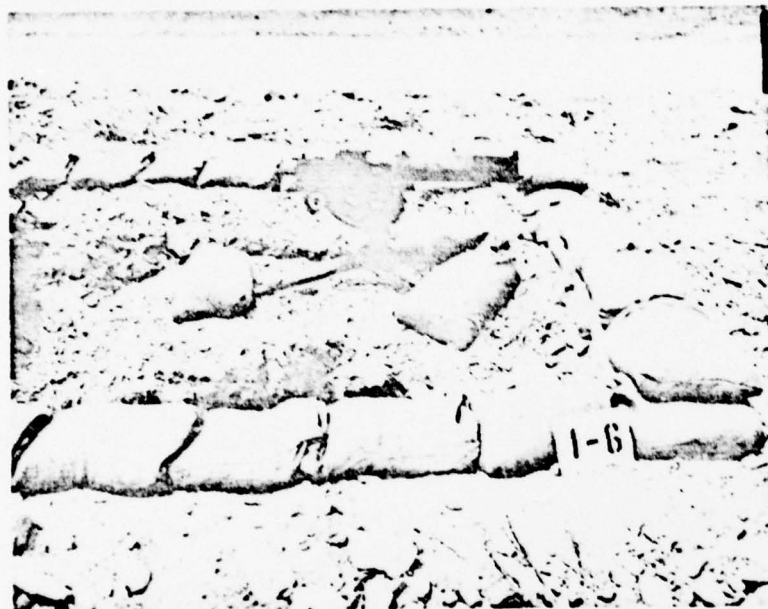
Machine Gun Cal. 30,  
M1917A1, dug in 550  
yards from GZ.

Blown out of emplace-  
ment. Barrel and jack-  
et bent. Damaged be-  
yond repair.

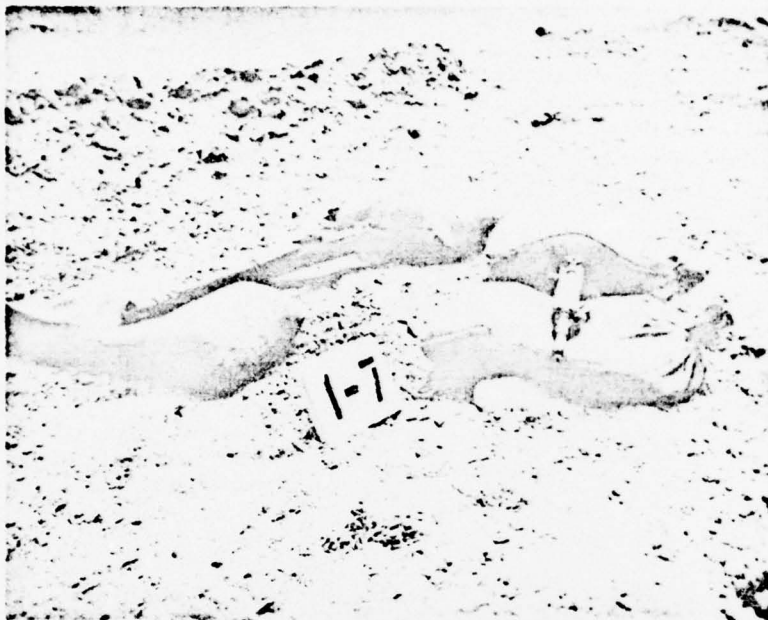
Rifle and Carbine  
wedged on sandbags  
and pointing at GZ  
from 550 yards.

Both weapons thrown  
about 50 feet. Car-  
bine stock broken,  
both stocks badly  
scarred.

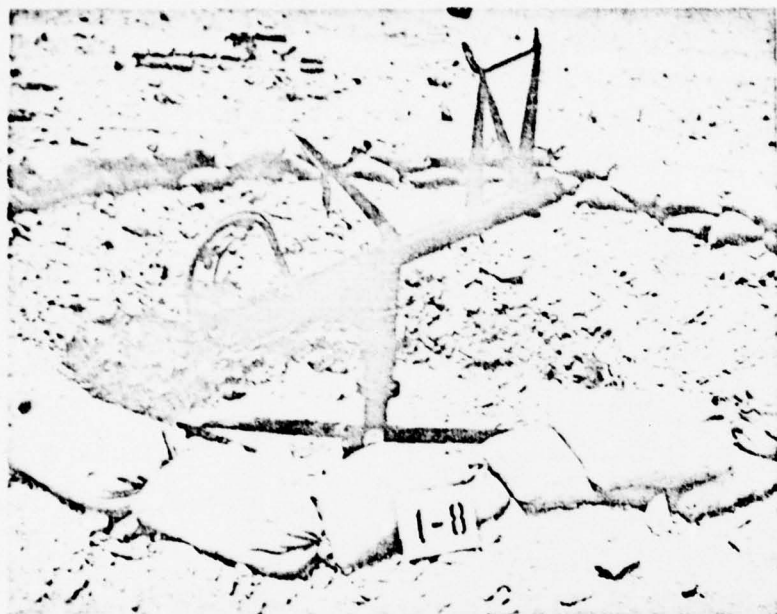
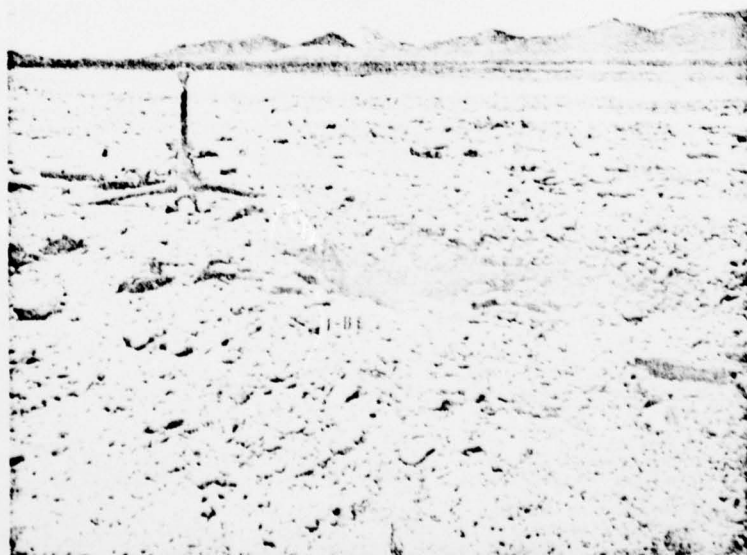
Machine Gun Cal. 50,  
AA, dug in 550 yards  
from GZ.

Blown out of emplace-  
ment and destroyed.

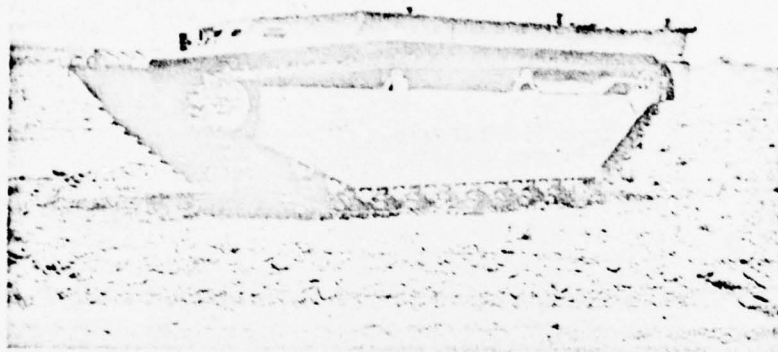
DVT (4) 570 yards  
from GZ.

Thrown approximately  
300 feet, landing up-  
side down. Hull severe-  
ly bent and twisted.  
Damaged beyond repair.
